Pearce Creek DMCF Exterior Monitoring Post-Placement Sampling Fall 2018 Results

Pearce Creek Implementation Committee
May 17, 2019

Project Overview

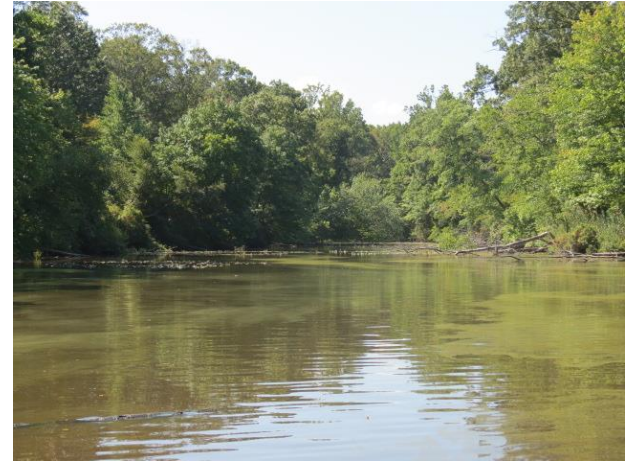
Location PCL-05

- Post-placement data comparable between the reference and the monitoring locations
- Post-placement data were also within the range of baseline concentrations, except for aluminum
- Turbidity: highly variable at Pearce Creek Lake locations because of natural factors (i.e., bank erosion, algae, or stormwater runoff)
- Chemical Testing - Metals
 - Low concentrations overall; generally consistent with results from previous sampling events
 - Aluminum exceeded chronic water quality criterion at one location
 - High bank erosion rates at this location increases turbidity and may contribute to aluminum concentration

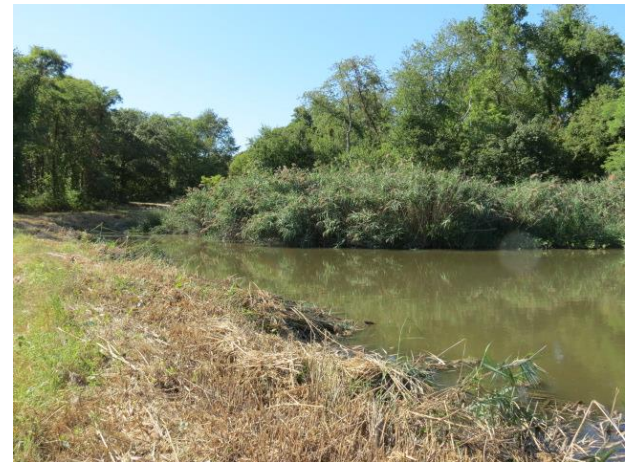
Location PCL-07

- Post-placement data comparable between the reference and the monitoring locations
- Post-placement data were also generally within the range of baseline concentrations
- Sediment Type
 - Pearce Creek Lake sediment comprised of silts and clays, although PCL-07 was sandy
 - Pearce Creek Lake reference location comprised of silts and clays
 - Elk River monitoring location was sandy with shell material
 - Elk River reference location was comprised of silty clays, with a lot of shell material
- Nutrients: Concentrations naturally variable at all locations

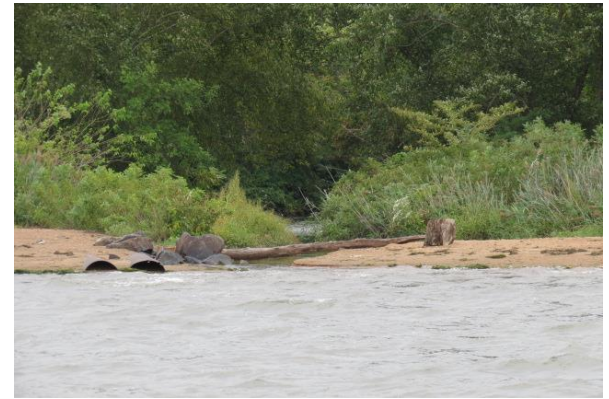
Elk River Connecting Channel – Elk River Outlet at High Tide

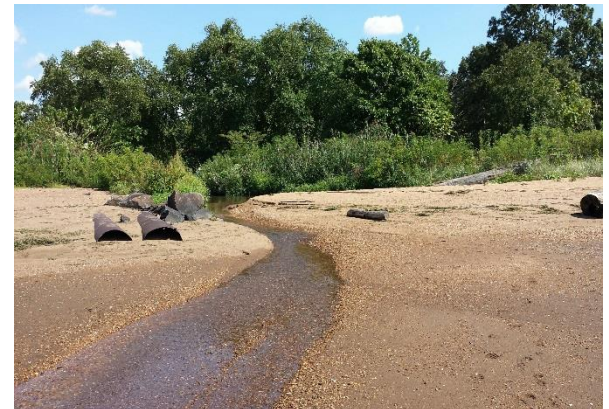
Elk River Connecting Channel – Elk River Outlet at Low Tide

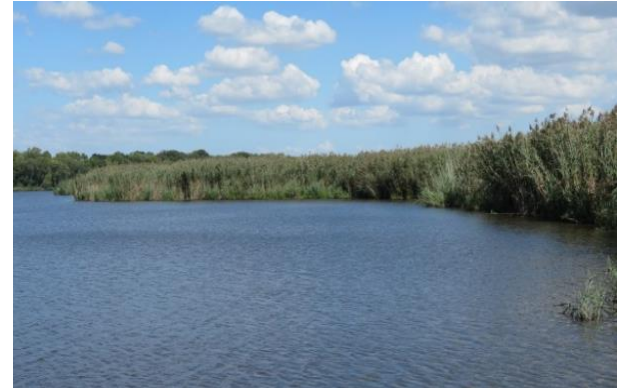
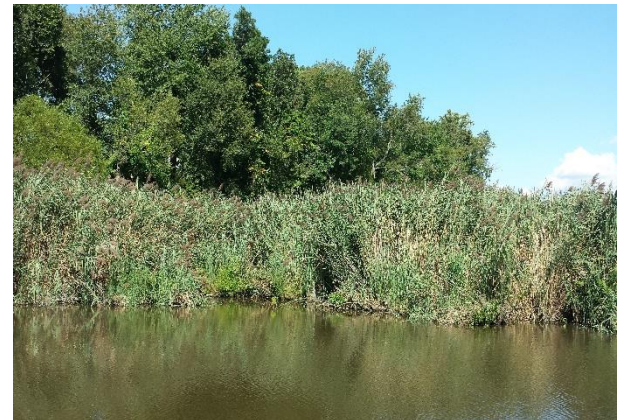
- 10-day whole sediment toxicity testing using *Hyallela azteca*: freshwater amphipod (laboratory cultured)
- Results for each location compared to reference site and to baseline data
- Results are consistent with the baseline data
 - Survival high for the Pearce Creek Lake and Elk River sediments
 - Sediments support benthic organisms

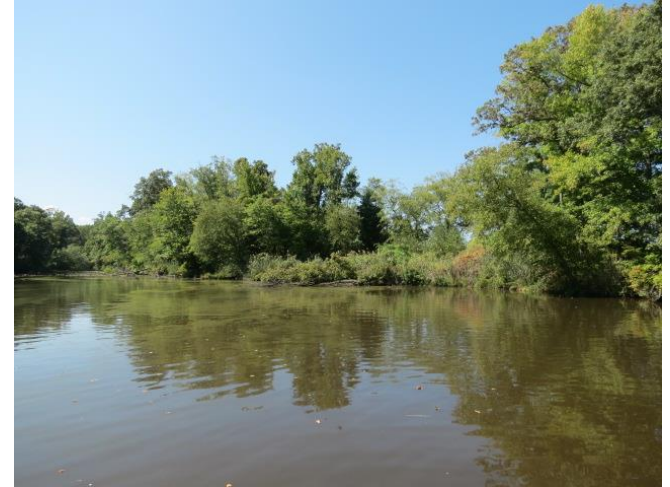
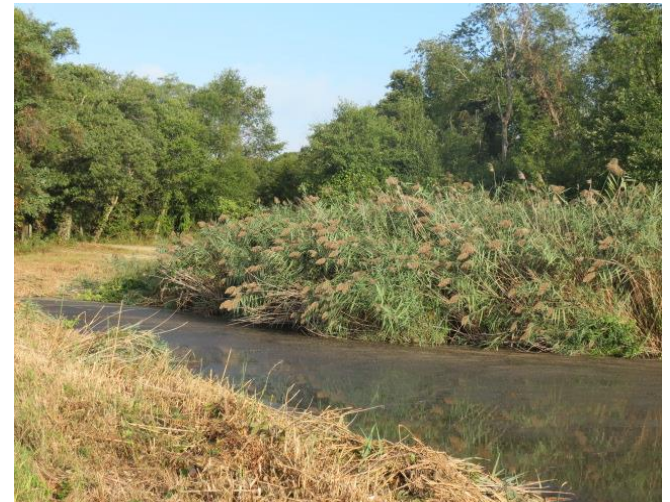
- Most of the metrics were within the range of the baseline data
- Observed one location that had one dominant species (PCL-07)
 - Skews the data – high abundance, but low diversity
 - Overall the conditions at the individual location did not change
- Abundance is highly variable at each location, but consistent with the baseline data (within the range of data observed previously)

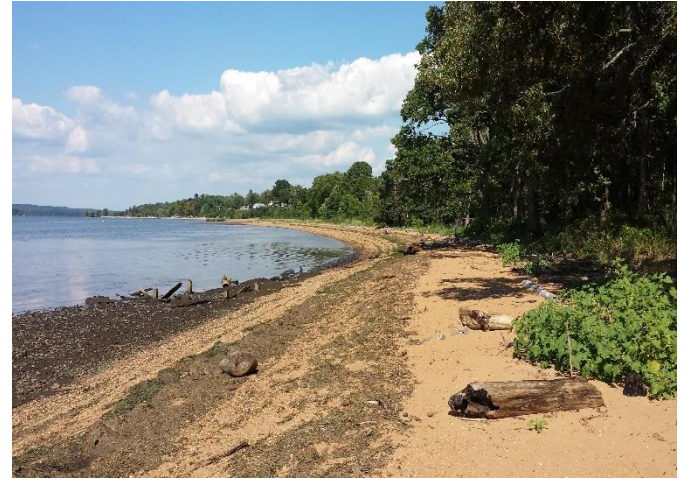
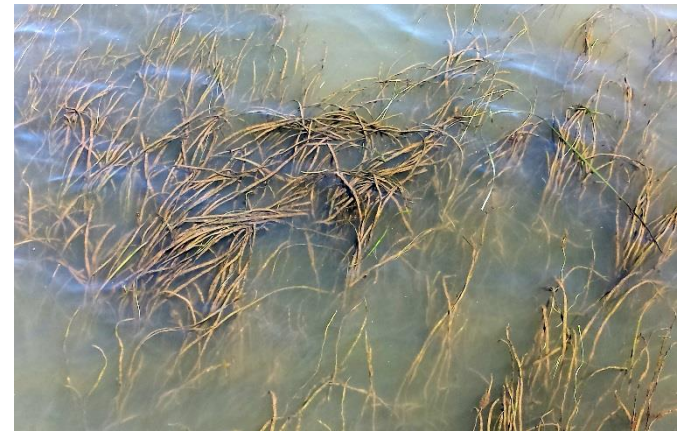
- Locations were classified as freshwater – no measurable salinity
 - Previous events were classified as oligohaline (salinity of 0.5 to 5 ppt)
- Turbidity was low (12 and 8 NTUs)
- Chemical Testing
 - Concentrations are very low; consistent with previous sampling
 - All of the samples were well below water quality criteria

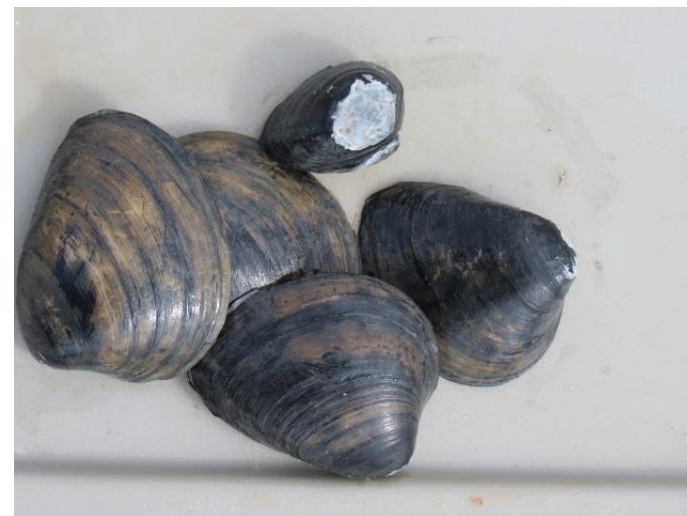
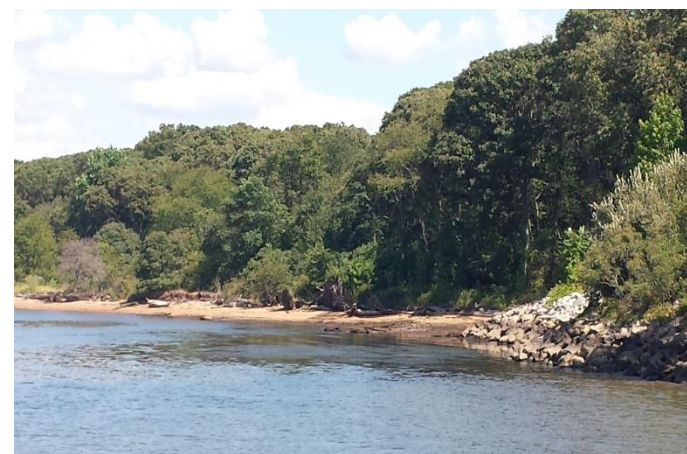
- Benthic Community
 - Abundance variable, but generally consistent with previous sampling events
- Benthic Bioassays
 - Both samples had high survival, therefore the sediment is not toxic
